## SERVICE BULLETIN

**TITLE: FLIGHT CONTROLS/STABILIZERS – AFT FUSELAGE, RUDDERVATOR, AND RELATED SYSTEMS INSPECTION FOR CONDITION**

Service Bulletin 27-3358, No Revision, is approved by the Manager, Wichita Aircraft Certification Office by letter dated February 11, 2000, as an Alternate Means of Compliance with AD 98-13-02, paragraph (f).

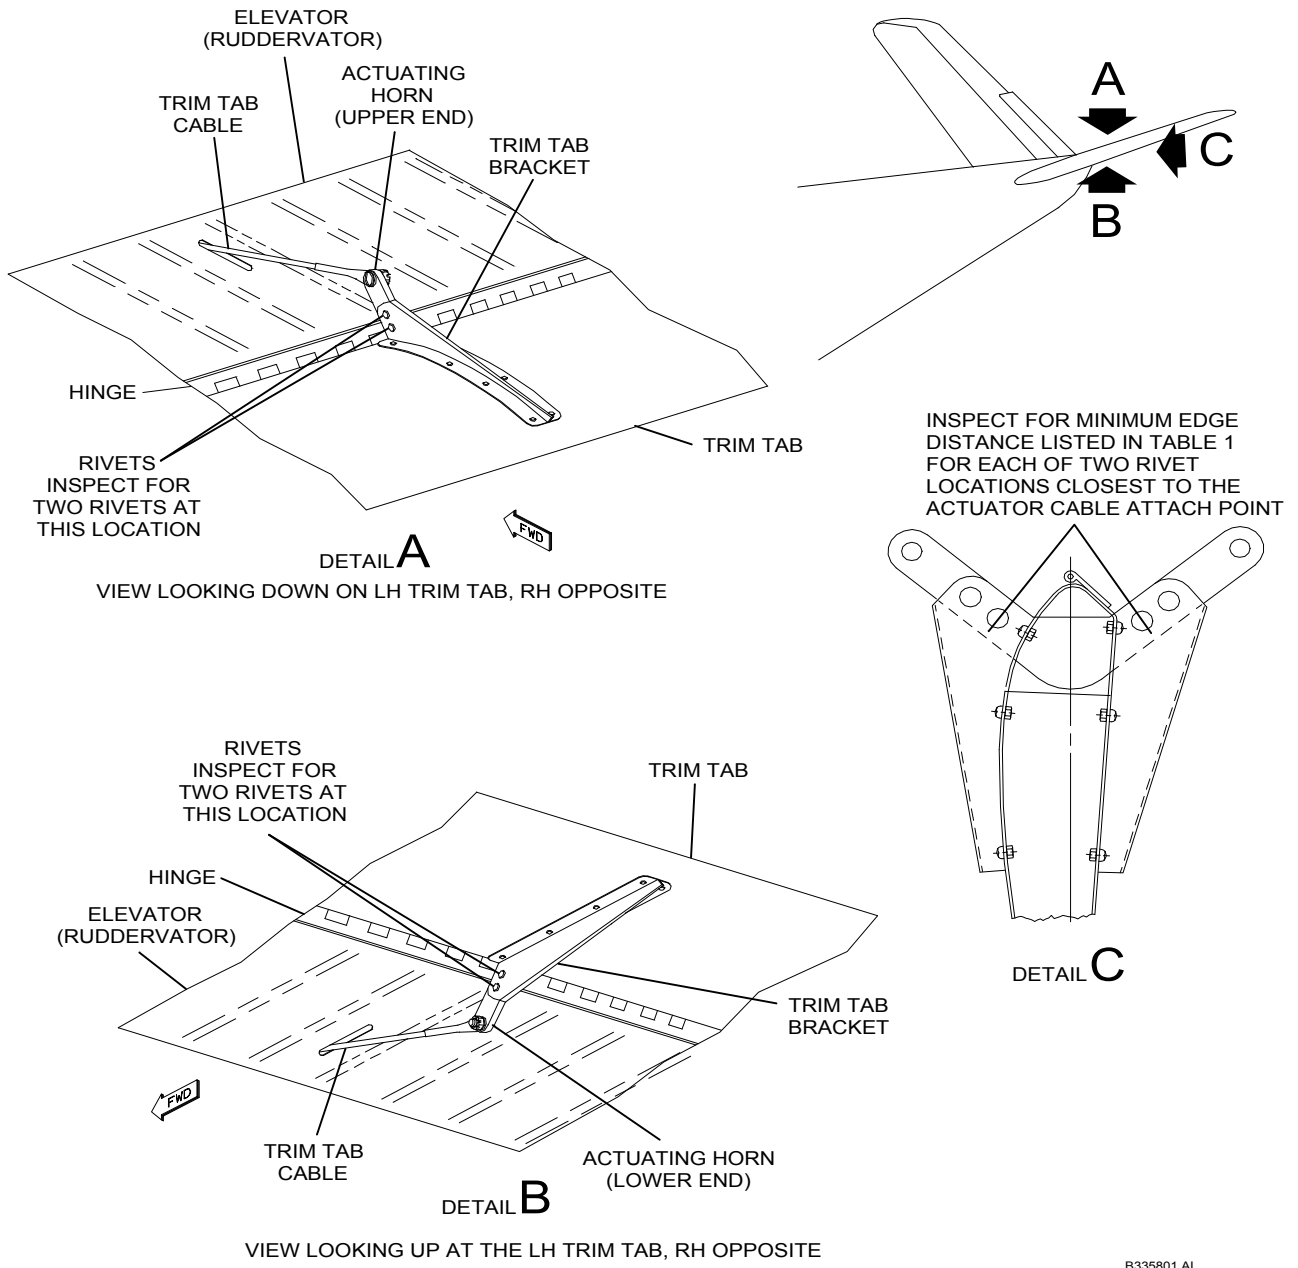
**Elevator Trim Tab Bracket Aft Rivet Edge Distance Inspection**  
**Figure 1**

**If edge distance on the elevator tab horn MS20470AD3 rivets is short, the tab horn may separate from the control surface, resulting in loss of rudder control.**

- (iv) Inspect for presence of two rivets securing each trim tab bracket to the actuating horn to confirm compliance with Service Bulletin No. 2605. Refer to Figure 1 and inspect for minimum aft rivet edge distance at each of the two rivets closest to the actuator cable attach points on the actuating horn using the following table:

MODEL	PART	BJ-3 RIVETS MINIMUM EDGE DISTANCE	BJ-4 RIVETS MINIMUM EDGE DISTANCE
• 35	Magnesium Horn	0.11	0.13
• 35	Aluminum Horn	0.05	0.063
A35	Aluminum Horn	0.05	0.063
B35	Aluminum Horn	0.05	0.063
